# Testing the Effectiveness of Baking Soda Media Blasting for Cleaning Fungal Contamination in Buildings

Dennis Melandro, Founder First Alert Emergency Services Rockville Centre, N.Y.

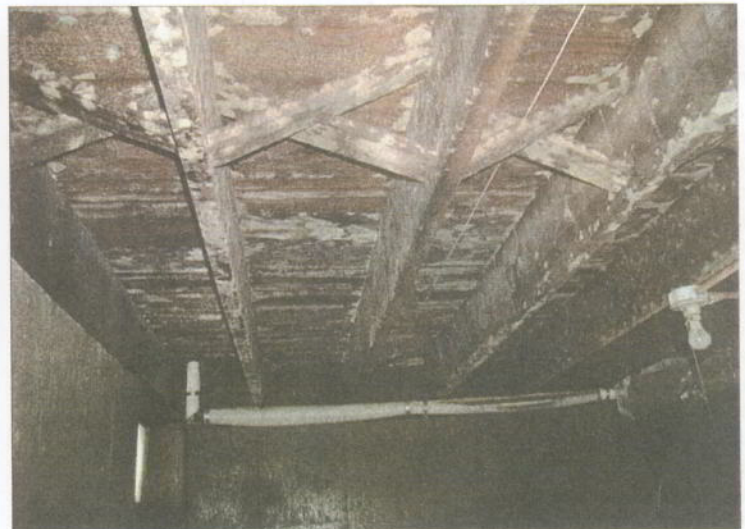
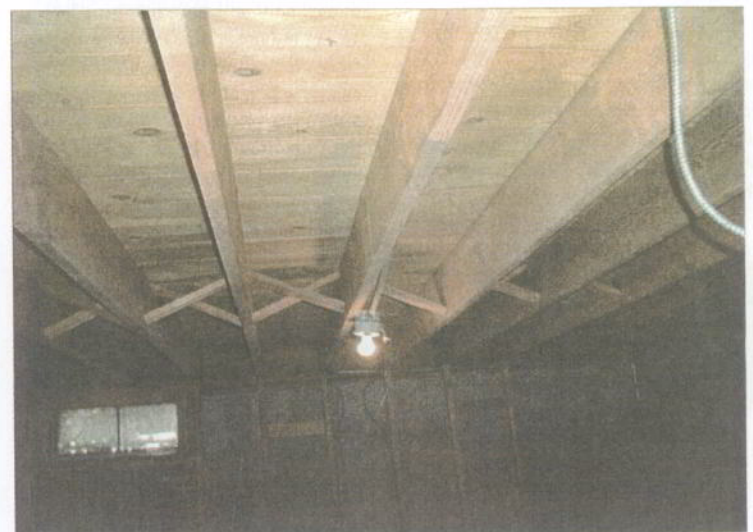
Photo 1

was wood-frame construction. It was an unoccupied rental property in which a basement pipe break and leak had gone undiscovered for approximately three weeks. By the time I was contacted, the basement had heavy visible mold growth on the two-by-eight-inch joists, sub-flooring of the floor above, and on the triple

two-by-ten-inch main headers. Insulation and the building contents were assumed to be contaminated as well. The first floor consists of four rooms, all of which had mold on plaster walls, and ceilings. The second floor has two bedrooms where mold was visible on the walls.

The spray blasting was to be followed by HEPA vacuuming to remove any media or debris residue, followed by vacuuming with a bio-wash. The client accepted my proposal. The problem area before and after our blasting treatment is shown in Photos 1 and 2.

As an alternative approach, I proposed removal of mold contamination from the framing surfaces using the Armex Accustrip system. This method entails a high-pressure compressed-air spray (consisting of a hopper holding the baking soda and a handheld gun for precision) using a baking soda abrasive. We've found that this method cleans irregular and problem surfaces such as subfloor with protruding nails and the multiple building framing cavities which would otherwise be both labor intensive and difficult to clean by manual scrubbing and vacuuming. I proposed that the Armex process be used to remove mold spores from the ceiling joists and main triple headers (as well as other surfaces).

In order to contain the mold, debris and baking soda residue while using the Armex Accustrip system, we kept the first-floor sub-floor in place until the media blasting was completed. Then, we removed the first-floor sub-floor and we hand sanded the now-exposed top side of the joists, followed by HEPA vacuuming and damp wiping. In other scenarios where there are windows, doors and opening we would set up critical barriers to contain the residue from the media blasting, while an air scrubber is filtering the air borne mold spores, baking soda and residue from the surface of which this method is being applied. During this procedure, all personnel were equipped with protective clothing and respirators.

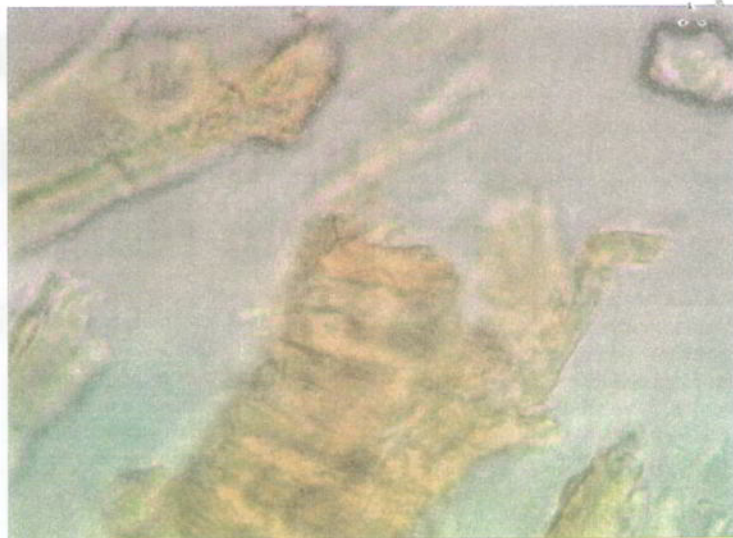
Photo 3

Chaetomium globosum, Chaetomium aureum and Stachybotrys chartarum are

dark molds frequently found in buildings that have been subjected to flooding. Their medical risk has been somewhat overblown by the excited news media, but they are indeed telltale organisms very often pointing to a presence of more serious fungal contaminants such as Penicillium sp. and Aspergillus sp. in the same buildings. These latter molds are

lighter in color and often grow hidden within building cavities. Unless they are quite heavy, colonies of these genera are often missed by a casual inspection which finds and reports "black mold."

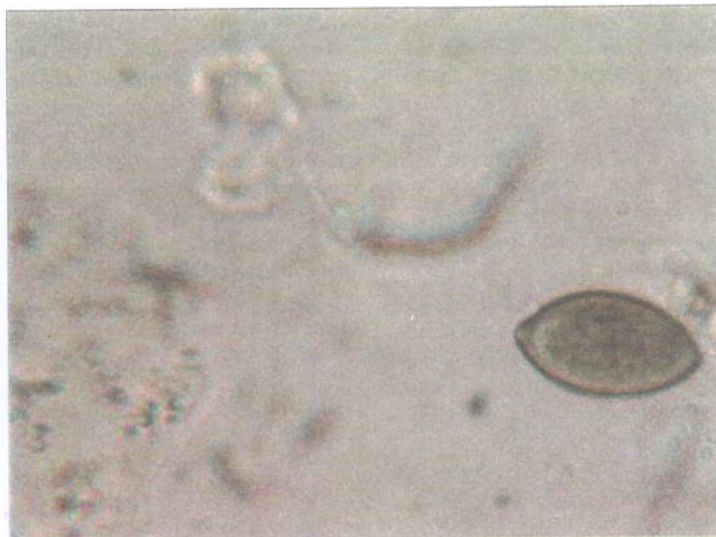
Photo 4

1. After blasting and before HEPA vacuuming, the sample area included contamination, which I speculate settled as airborne debris. In these samples, I found fiberglass fragments, debris, cellulose fragments more frequent than in after-HEPA vacuuming sample below, and I found both individual fungal spores spore clusters including basidiospores, *Periconia* sp., and unidentified fungal conidia and hyphal fragments which appeared to be *Chaetomium globosum* particles, perhaps fractured by the blasting process. See Photos 3 and 4. On other studies, I have also found fairly uniform surface contamination by fungal debris, mostly hyphal fragments, when an inexperienced contractor used contaminated wipes and a contaminated vacuum attachment across many surfaces.

These results suggest that the media blasting approach is effective in cleaning exposed wood surfaces of fungal contamination, but that special care needs to be taken to avoid recontamination by airborne, contaminated dust, vacuum attachments, or surface wipes. Contractors need to look carefully at dust control, vacuuming and wiping methods to take full advantage of the cleaning provided by surface blasting.

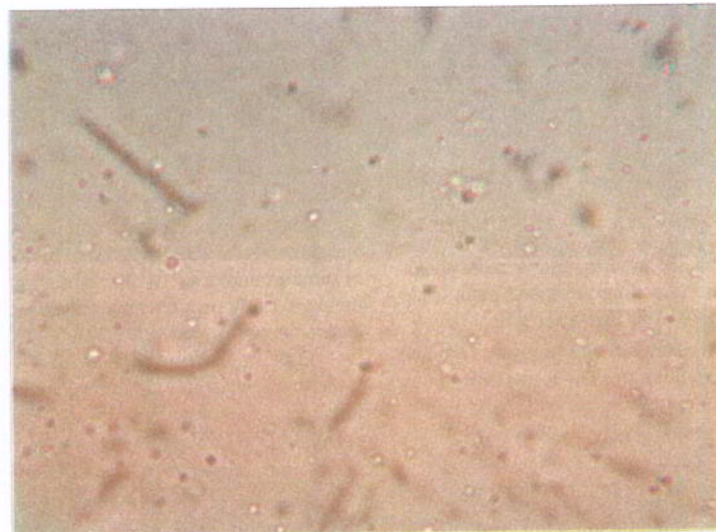
Photo 5

2. After HEPA vacuuming and wiping, the sample was clean of fungal spores. It contained incidental occurrences of media particles less than one micron in size, cellulose particles that I speculate were removed from the blasted wood surfaces, and skin cells. There were no fungal spores found in the sample. See Photo 5.
